IN RE: BOSTON SCIENTIFIC CORP.,  
PELVIC REPAIR SYSTEMS,  
PRODUCTS LIABILITY LITIGATION  
-----

MDL NO. 2326

**RULE 26 EXPERT REPORT OF DR. VLADIMIR IAKOVLEV, MD**

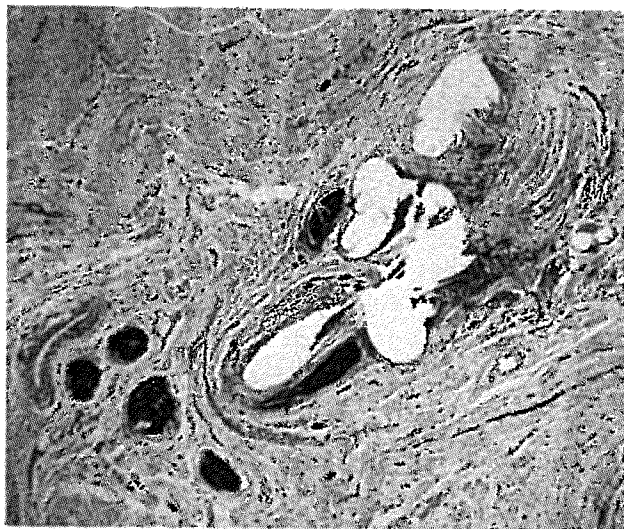
**Figure 1. Examples of nerve ingrowth and entrapment**

Immunostain against S100 protein, which is present in Schwann cells, stains peripheral nerves (nerves brown, all other tissue blue, mesh filaments transparent on the left and filled yellow on the right). The nerve branches enter between the mesh filaments and grow into the spaces of mesh structure. This is defined as nerve ingrowth since the spaces were created by the mesh placement into the body. These spaces are filled with dense collagenous scar, which fuses the nerves in their position – entrapment. In our study this phenomenon has been identified in 100% of explanted transvaginal meshes. All these patients had complains of pain.

The spaces within the mesh structure are not present before surgery, therefore a position of nerves within the mesh indicates ingrowth. Examples of nerve ingrowth into the mesh structure are shown in Figure 1. As mentioned earlier, the female genital area has much higher nerve density compared to the anterior abdominal wall and groin. In our studies nerve ingrowth has been detected in 100% of transvaginal meshes and over 90% of meshes from other sites explanted due to pain. The nerve branches can be also trapped in the scar tissue surrounding the mesh. This can further be complicated by a deformation of the mesh-scar conglomerate (Figure 2). In cases of nerve entrapment, movement or external pressure applied to the tissue deforms or moves the mesh and the force is transferred directly to the nerves. Pain on movement or external pressure can also be due to mesh hardening and attachment to tissue components. In this cases receptors in the pulled

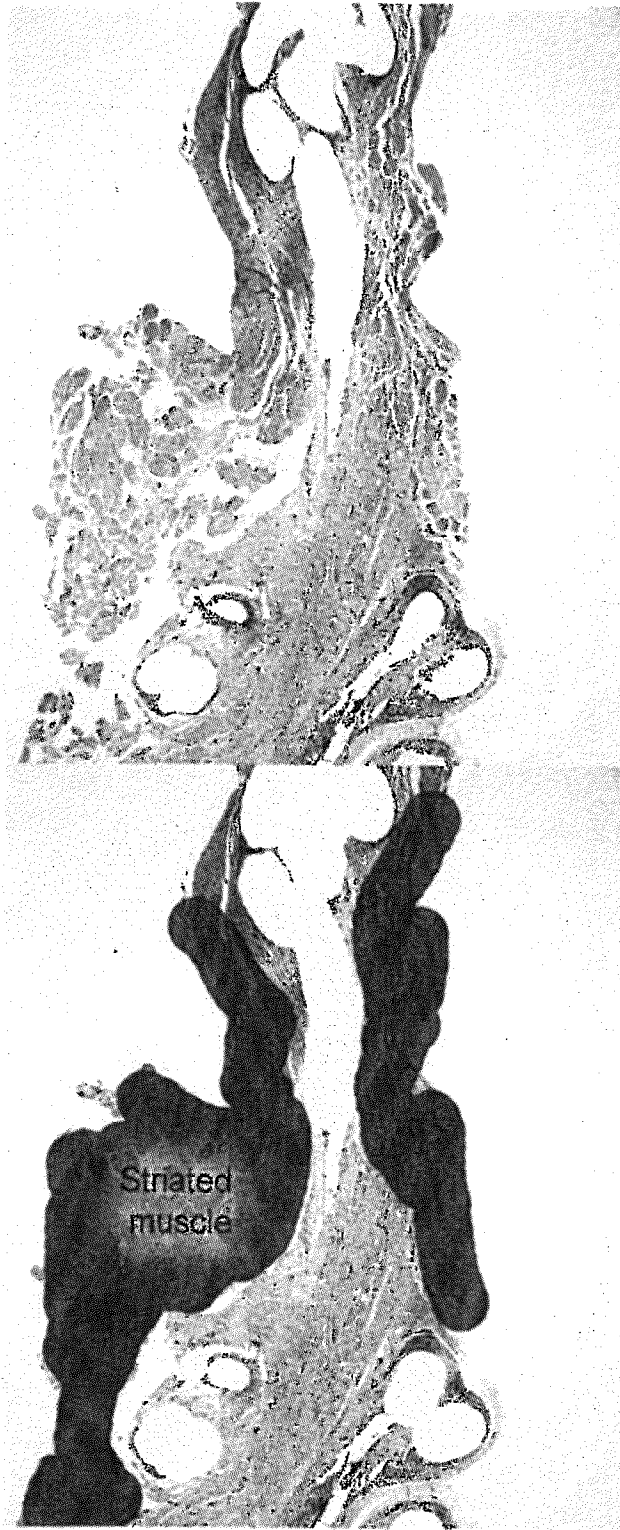
**Figure 7. Striated muscle anchoring to the mesh**

An example of striated muscle (red on the right) anchoring through the mesh. Striated

(skeletal) muscle provide conscious (voluntary) movements of our body. In this case movements, which are achieved by contraction of this muscle moved (tugged) the mesh as well.

Striated muscle, if connected to the mesh (Figure 7&8), can be a cause of mesh migration or deformity. The connection was detected in specimens which included striated muscle. Smooth muscle connection is a more frequent finding (Figures 9&10), which also applies a pulling force on the mesh.
